Minerals Inspection Report

Report Date: **06/03/2015**

Mine Name: Tom Taylor	Permit Number: S/47/0065	Mine Status: Reclaimed
Operator Name: Zeigler Chemical	Inspection Date: 5/5/2015	Permit Fees: Paid
Inspector(s): A. Abate	Inspection Time: 11:00 AM	Bond Amount:
Attendee(s): Stan Perks - BLM, Chip Zeigler, Zeigler	Weather: Clear 60F	Bond Escalation:
Inspection Purpose: Determine if the site is in reclamation		Prior Inspection: 5/31/2007

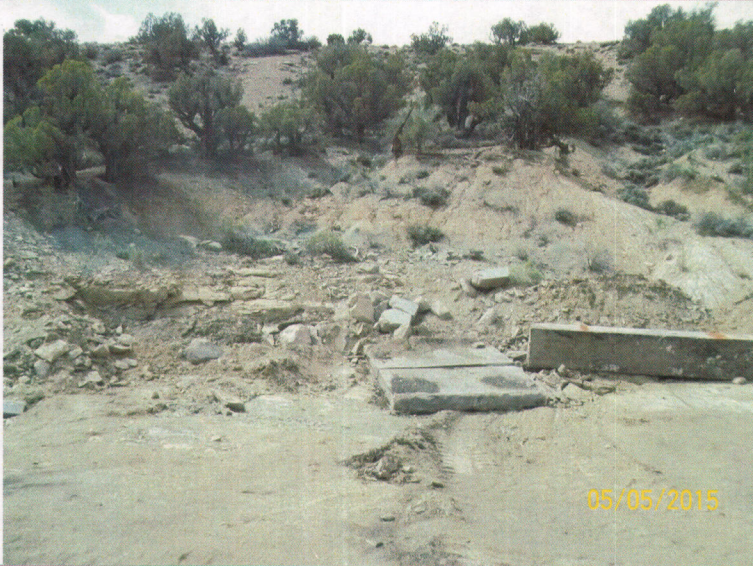
The concrete cap is located just below the juniper trees. Some concrete was still present at the time of the inspection. The operator was in the process of removing it.

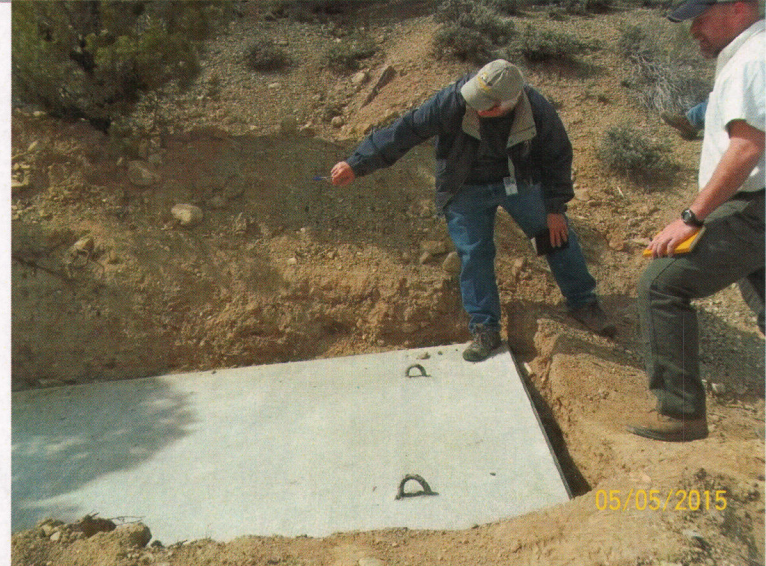
The BLM inspects the concrete caps to make sure they meet their requirements.

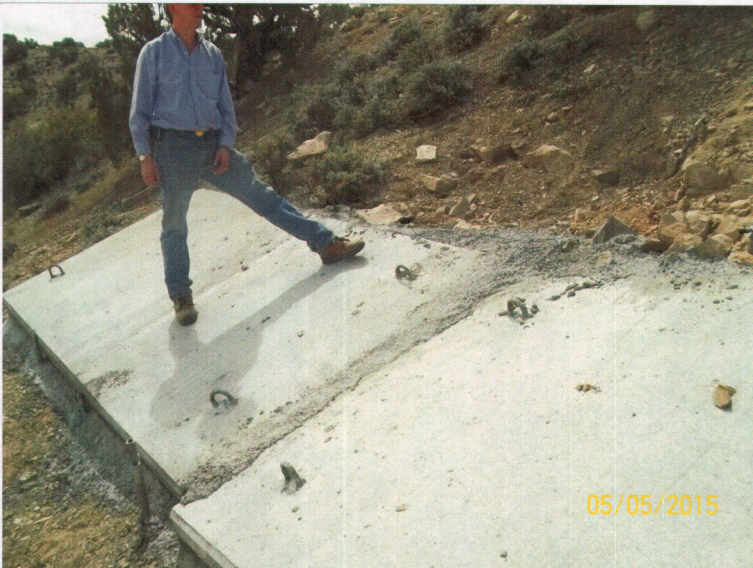
2. <i>Public Safety (shafts, adits, trash, signs, highwalls)</i>	<input checked="" type="checkbox"/>	<input type="checkbox"/>
A total of 5 shafts were capped with concrete. The dimensions of the caps were required to meet BLM standards. BLM was on-site to confirm that the caps met their standards. There was some discussion about how to make the caps blend with the landscape and to prevent water from eroding around the edges of the cap that was situated on a steep hillside.

View of one of the five the concrete caps located on a steep slope.

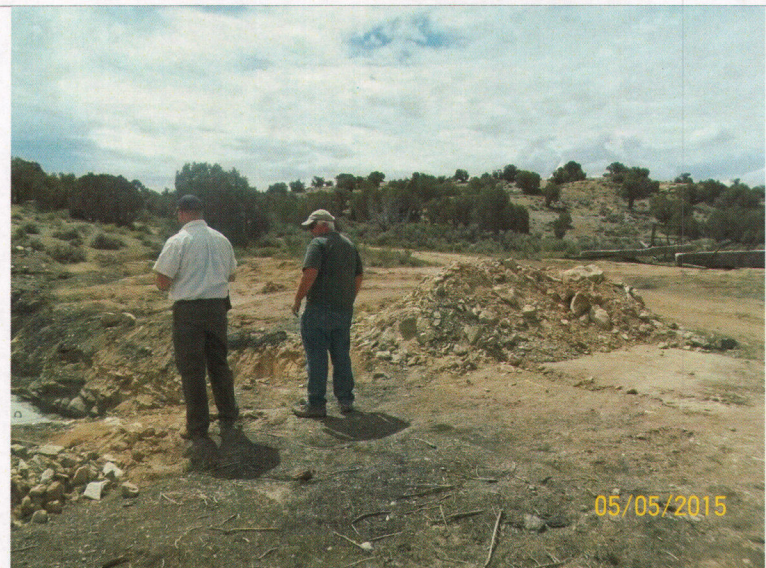
Small rubble piles were still on-site at the time of the inspection that the operator was in the process of cleaning up.
